WADC TECHNICAL REPORT 57-477 (II)

HIGH ALTITUDE BALLOON DUMMY DROPS

II: THE STABILIZED DUMMY DROPS

AUGUST 1961

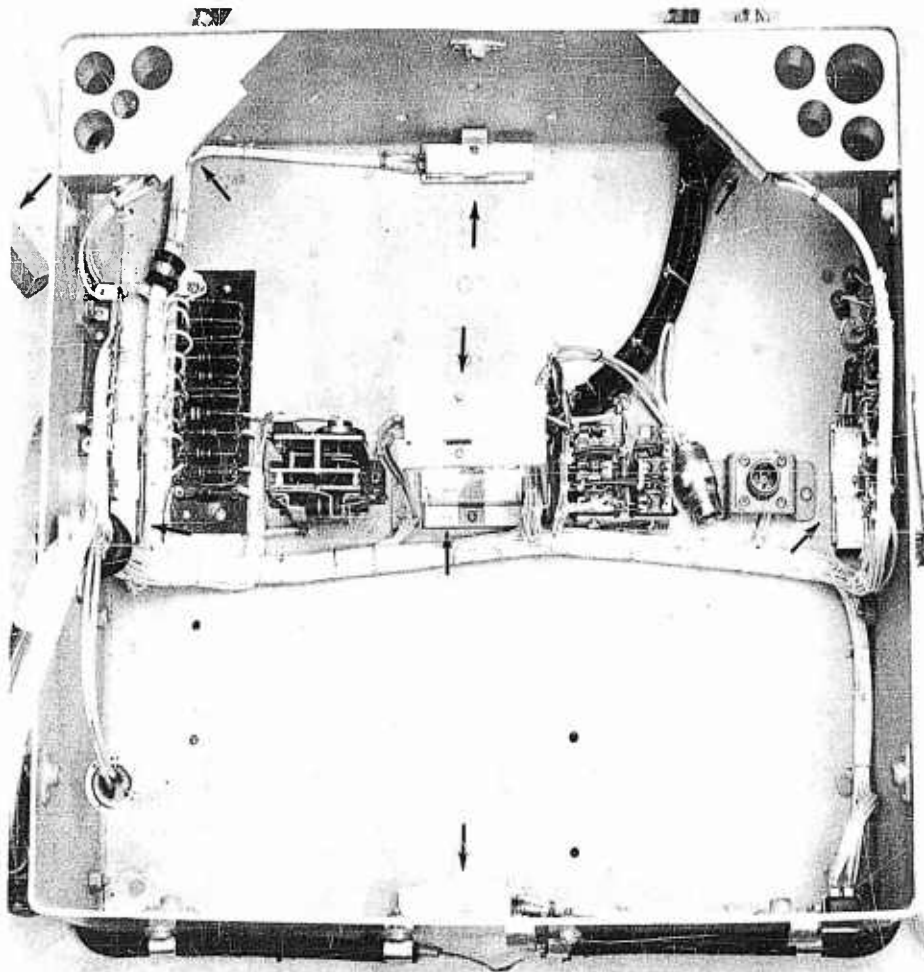
Figure 1. Accelerometers in Series I Instrumentation

Instrumentation for Series I drops was the same as that used during the unstabilized drops. It included the same 11 accelerometers ranging from 6 to 10 g (figure 1), which fed data into a recording oscillograph, and a modified N-6 GSAP 16 mm camera with a wide-angle lens. In addition to that used in the unstabilized drops, there were two pressure transducers mounted within the kit, and a camera mounted on the dummy's shoulder. Pressure data were collected by mounting a pitot tube on the dummy's foot and running two hoses from the tube to external kit connections of the transducers. One

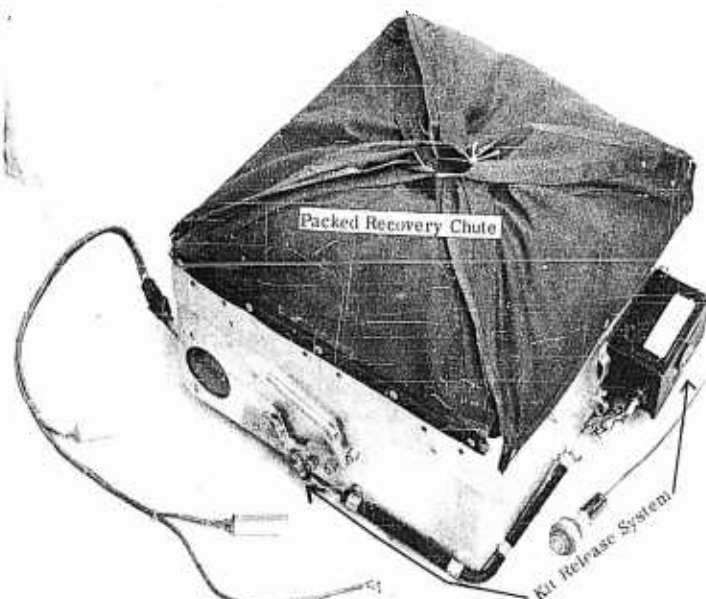
Figure 2. Kit Recovery System

During the first stages of the unstabilized dummy drops, attempts were made to recover the instrument kits attached to the dummies. However, the dummies landed on the kits, crushing, or damaging the instruments. Therefore, a new system incorporating an automatic parachute release armed by a static line was developed to separate the kit from the dummy after the dummy's main parachute had opened. As the kit dropped away, the static line on the kit deployed the kit-recovery parachute (figure 2).

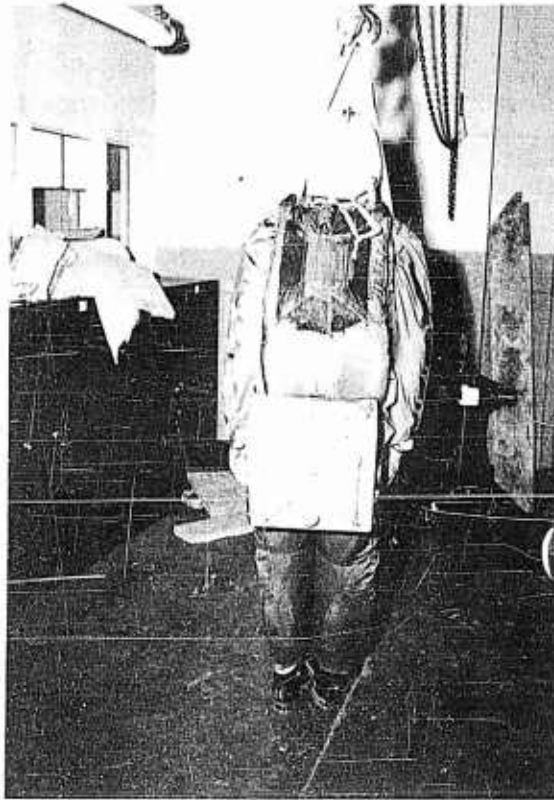
Figure 3. Five Float Drogue Chute Combined with B-5 Pack

The second configuration tested in this series was an automatically deployed 5-foot stabilization chute combined with a standard B-5 pack (figure 3). The chute was deployed by an automatic parachute release timer with the aneroid timer removed. This timer was activated by a static line as the dummy was released. Following a preset period of free-fall, the timer "fired" and deployed the first-stage parachute. Two drops were made with this configuration, and again both assemblies failed. The malfunctions were traced to snagged risers which prevented the parachute system from operating.

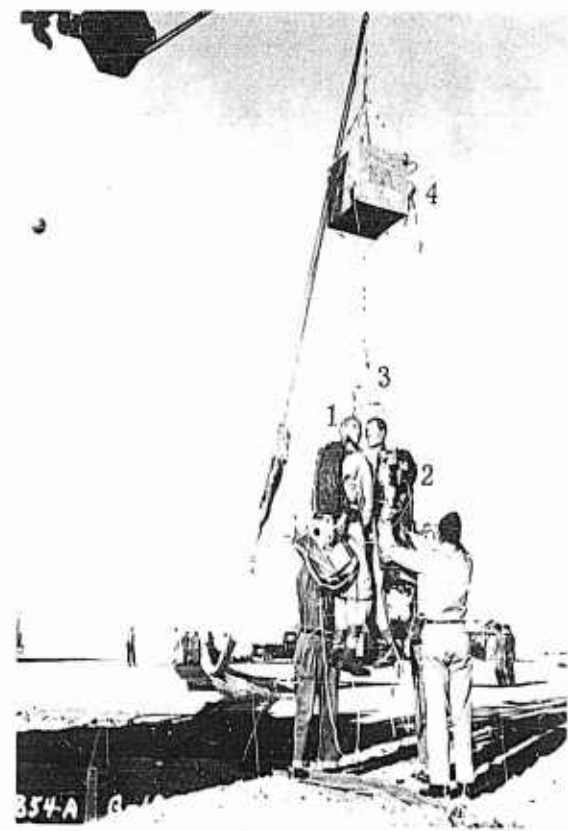
Figure 4. Series I Dummy-Balloon Attachment
 1. Unstabilized Dummy
 2. Stabilized Dummy
 3. Cutters
 4. Cut-Down Command Box

Since Series I drops were integrated with the unstabilized drops, the method of attaching dummies to the balloon remained the same. The dummies were attached below the balloon instrument package with the suspension lines threaded through squib-fired cutters (figure 4). The dummies were released from the balloon via ground radio command through the balloon instrument kit; Dummy No. 1 preceded Dummy No. 2 by 5-10 seconds. Dummy No. 2 was delayed to prevent any possibility of one dummy fouling the other's equipment during descent. As Dummy No. 1 was released, it would drag and scrape down the torso of Dummy No. 2 until it was free of the balloon-borne package. The close contact at cut-down endangered the equipment worn by either or both dummies, and thereby the test results.

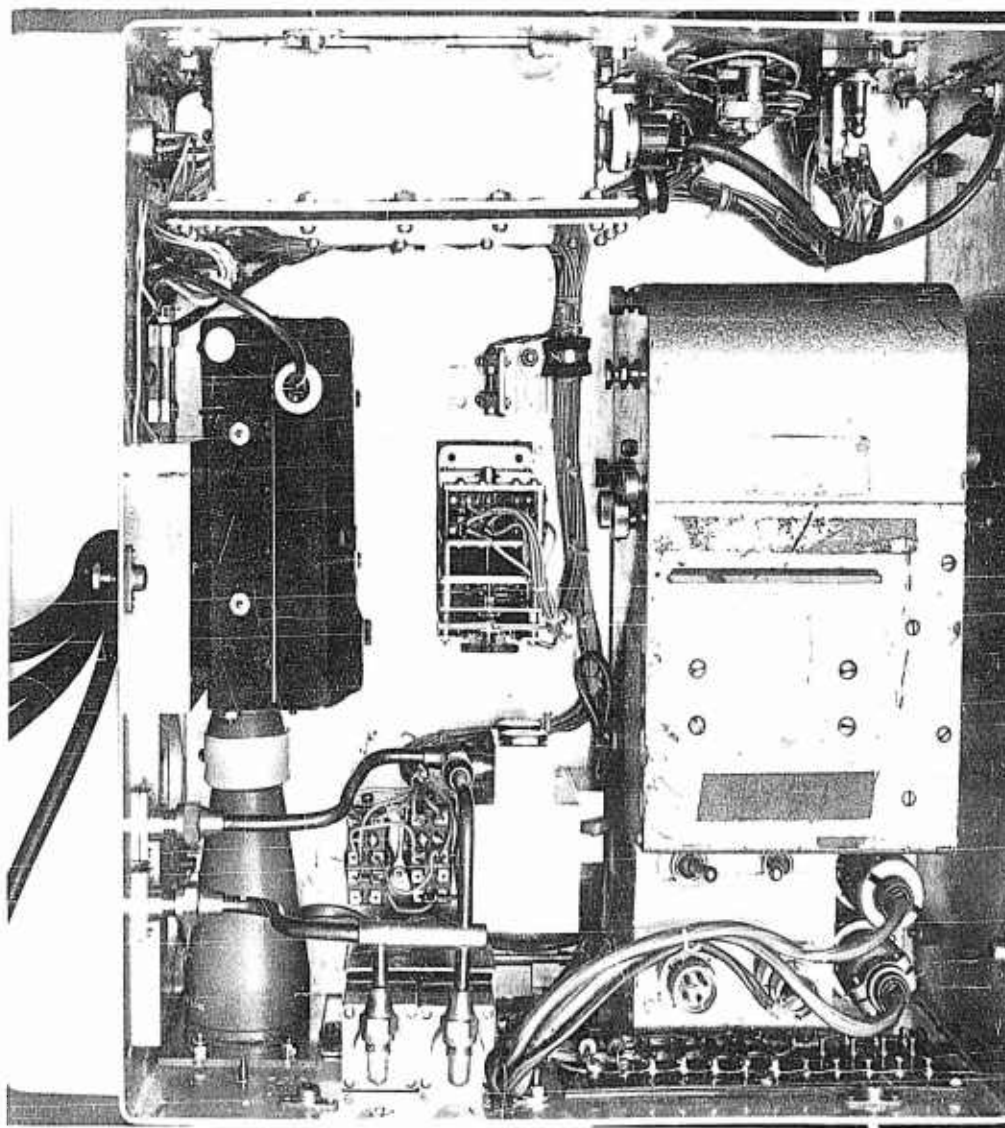
Figure 7. Series II Instrument Kit

The instrumentation kit for Series II was redesigned. It incorporated two 10-g accelerometers to measure transverse and lateral forces, two pressure transducers to measure ambient and differential pressures, two modified N-6 GSAP cameras (one inside the kit and one shoulder mounted) and all additional necessary electronic equipment (figure 7). This kit eliminated nine accelerometers, incorporated different transducers, and made other changes in kit calibration, activation, and operation. These changes in kit design resulted in various problems of integration with personal equipment, checkout, and maintenance not previously encountered. As the second series of drops progressed, it became increasingly evident that data collection with this instrumentation was also unsatisfactory because of extreme environmental conditions.

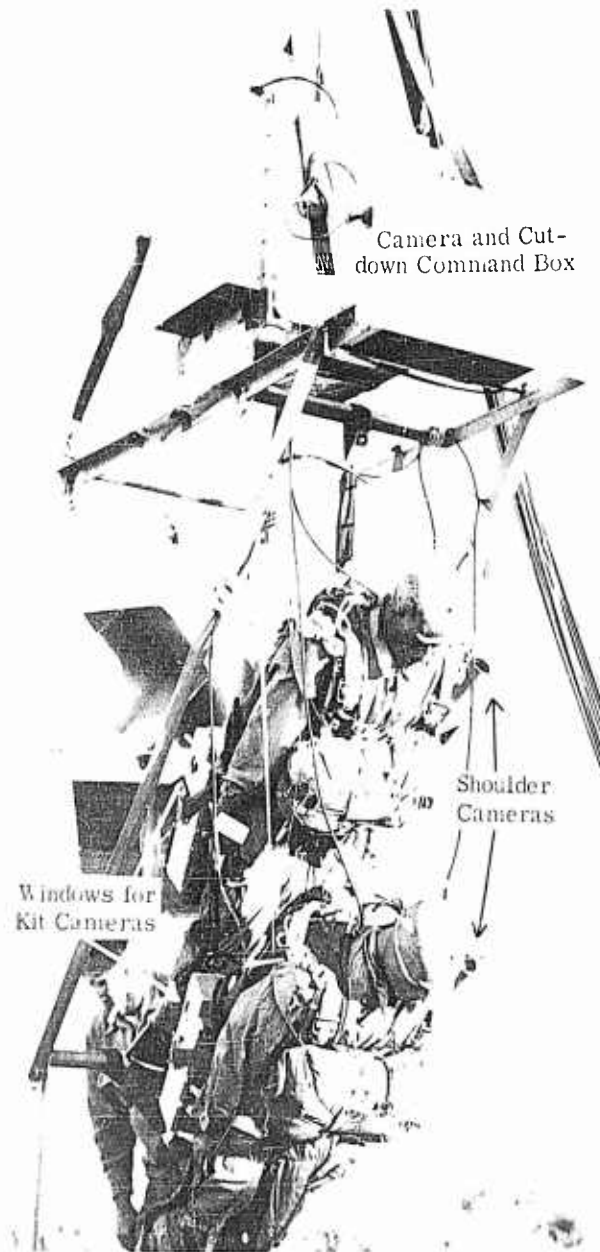
Figure 8. Series II Camera System
 1. Camera and Cut-Down Command Box
 2. Shoulder Cameras
 3. Windows for Kit Cameras

During this Series, a new dummy-launch rack incorporating a camera box and a cut-down command box was used. The camera box contained three N-6 GSAP cameras, each equipped with a different focal length lens ranging from an 84 degree wide angle lens to a 4-inch telephoto lens (figure 8). Later modifications in this Series incorporated two additional rack-mounted cameras, and the previous camera box and the command cut-down box were relocated. The rack-mounted cameras collected sufficient data from which we determined the parachute required further development. During Series II, these cameras became the primary instruments for collecting data. Dummy-borne cameras remained mounted on the dummy's shoulder as in Series I tests. Due to the problems of static-line deployment, motion picture coverage of dummy release and first-stage deployment were mandatory.

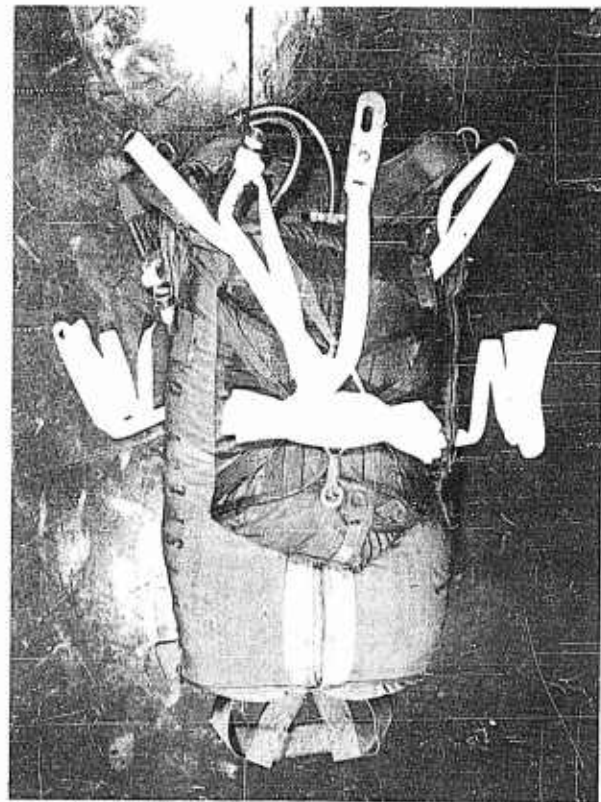
Figure 9. Static Line Deployed Six Foot Drogue on B-5 Pack

A static-line-deployed 6-foot stabilization parachute integrated with a standard B-5 pack (figure 9) was used during this Series. The assembly was tested by numerous aircraft drops before it was proved for use in the balloon project. As these tests began concurrent dummy and live jump tests were conducted

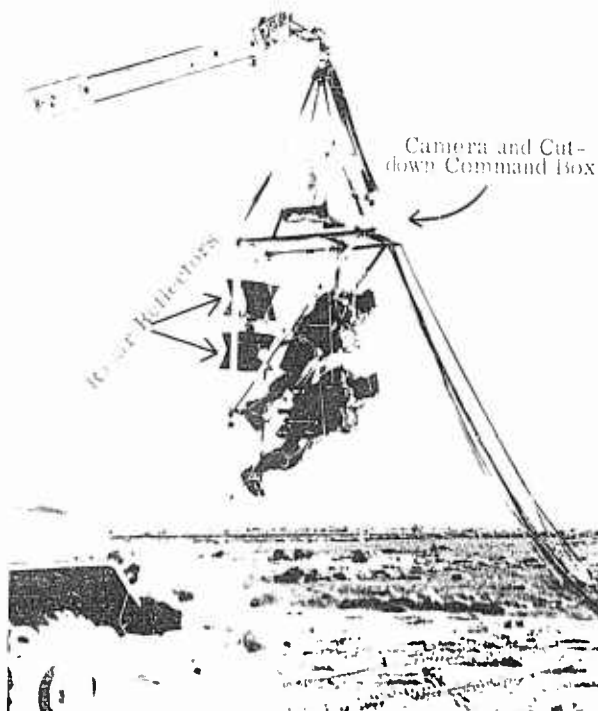
Figure 10. Series II Dummy Launch Rack
 1. Radar Reflectors
 2. Camera and Cut-Down Command Box

A rigid dummy-launch rack was designed and fabricated. It accommodated two diagonally suspended dummies, radar reflectors, a camera box, and a cut-down command box (figure 10). The rack was suspended by a harness which supported the balloon instrument kit and attached to the test package recovery parachute. This parachute linked the balloon to the test package (figure 11). Dummies launched from this diagonal position were immediately thrown into a tumble, thereby inducing the worst possible condition for first-stage deployment. After several drops in this configuration, it was decided to test first-stage deployment under optimum conditions. The rack was modified to permit vertical suspension of the dummies and the camera box and the cut-down command box were relocated to provide complete coverage throughout the dummy-release profile (figure 12). This configuration was employed on the last two Series II drops.

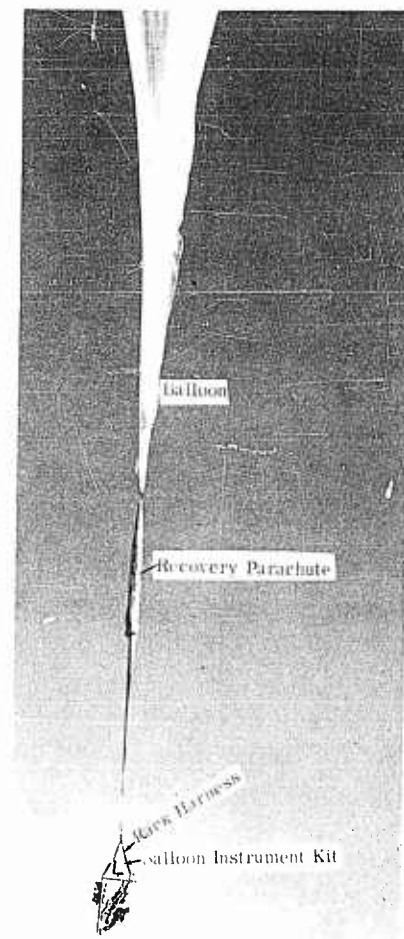
Figure 11. Launch Rack-Balloon Attachment

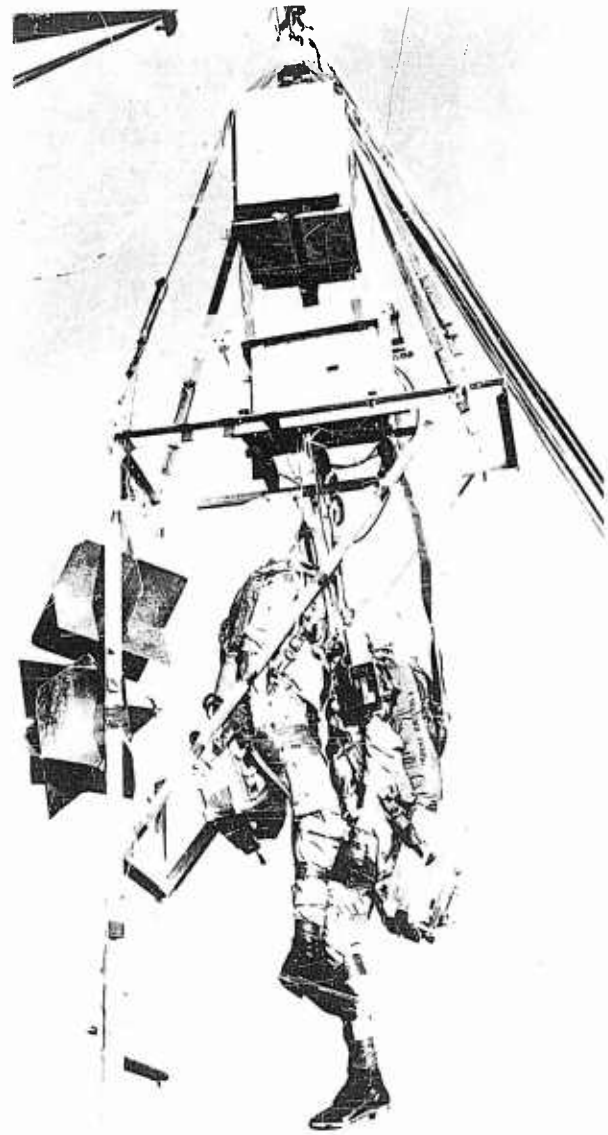
Figure 12. Modification for Vertical Dummy Suspension

Following Drop 061, the dummy-launch rack was modified to test deployment of the stabilization chute under the most favorable conditions. This was done by providing a suspension bar from which the dummies could be suspended in a vertical position. The camera box and the cut-down box were also moved to allow motion picture coverage of the dummies from the time they were released until they vanished far below the rack.

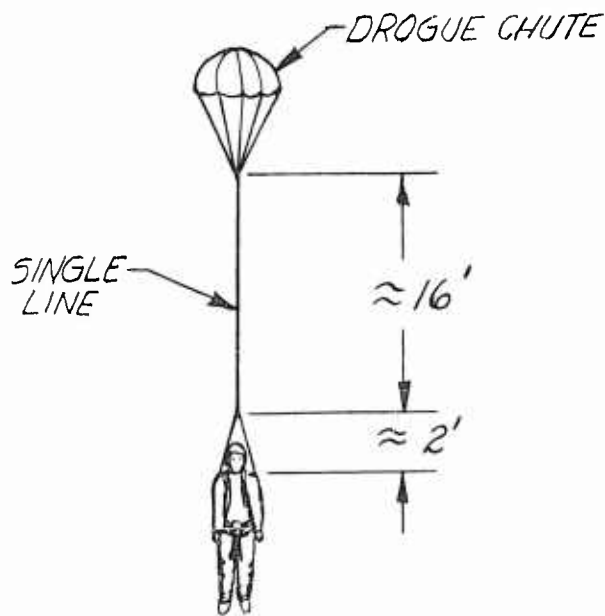
Figure 13. Single Elongated Riser System

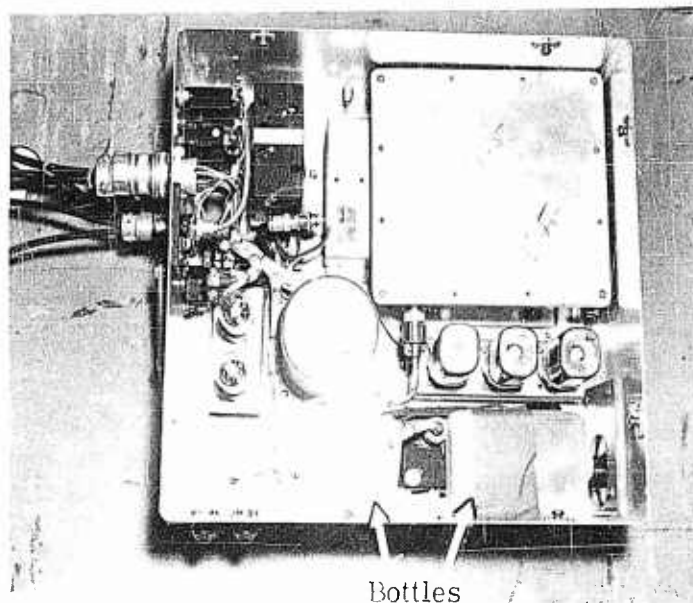
Figure 15. Insulation Bottles Around Kit Camera

While preparing for Series III, an effort was made to insure complete photographic coverage by the test package cameras. The external kit surfaces were painted black to absorb heat and the kit cameras were insulated with plastic bottles containing water at ground-level temperature (figure 15).

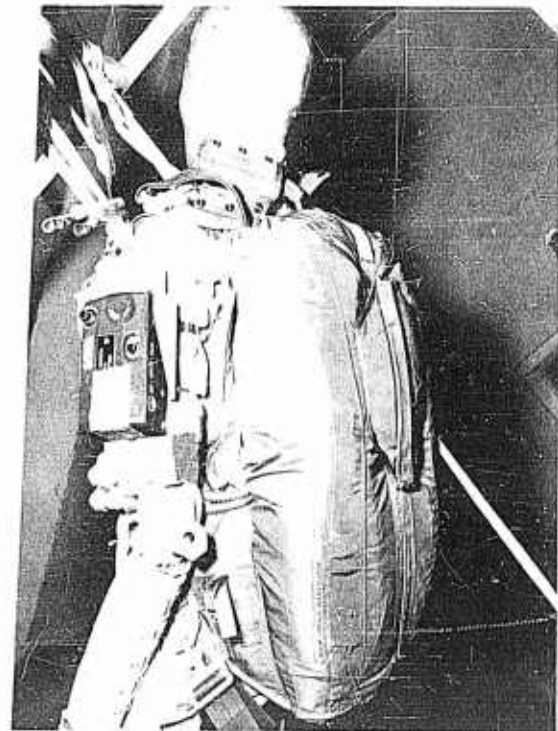
Figure 18. Series III Parachute (Resembles Standard B-5)

Series III incorporated a major change in the stabilization concept. In contrast to all previous "piggy-back" stabilization-chute configurations, the final multistage parachute had the appearance of a B-5 pack (figure 18). It employed two automatic parachute release timers that were activated by static line as the dummy left the balloon. The first release, with the aneroid assembly removed, deployed the stabilization chute and three quarters of the main canopy. The main canopy functioned as suspension lines for the drogue chute until the dummy descended to 17,000 feet, where the second parachute release fully deployed the main canopy.

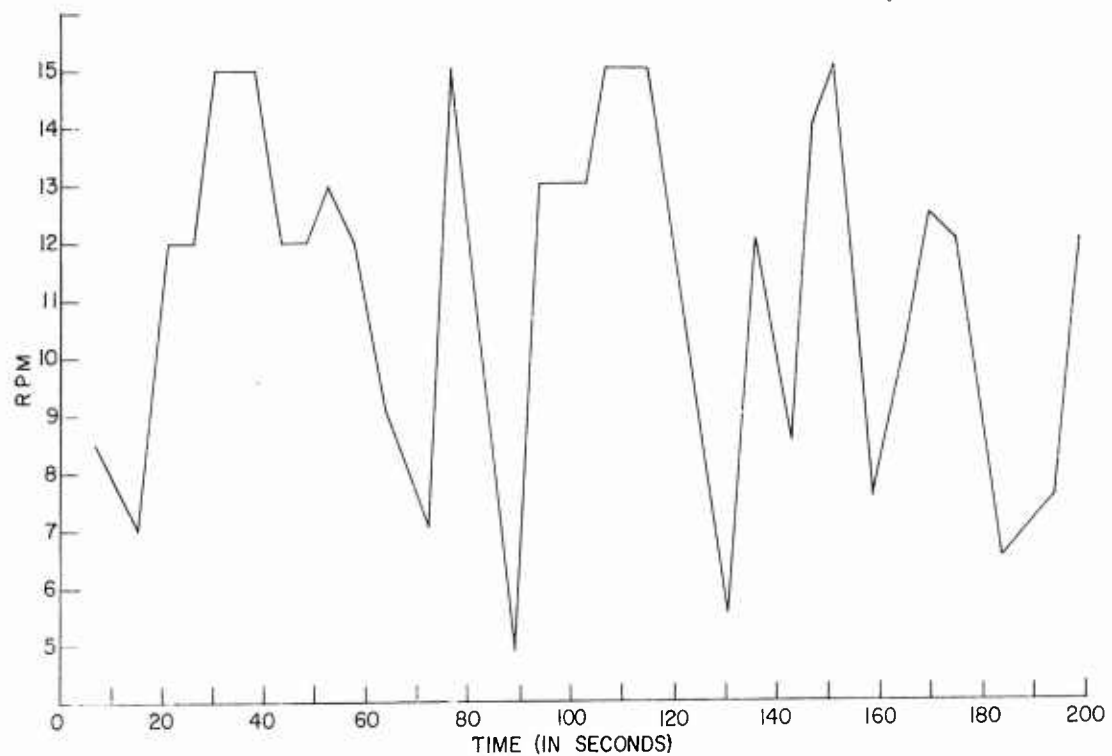
Figure 19. Series III. Data Reduction Sample Dummy Number 1, Drop Number 067

13 sec. free fall before 1st stage parachute deployment at approximately 64,000 ft (mean sea level)

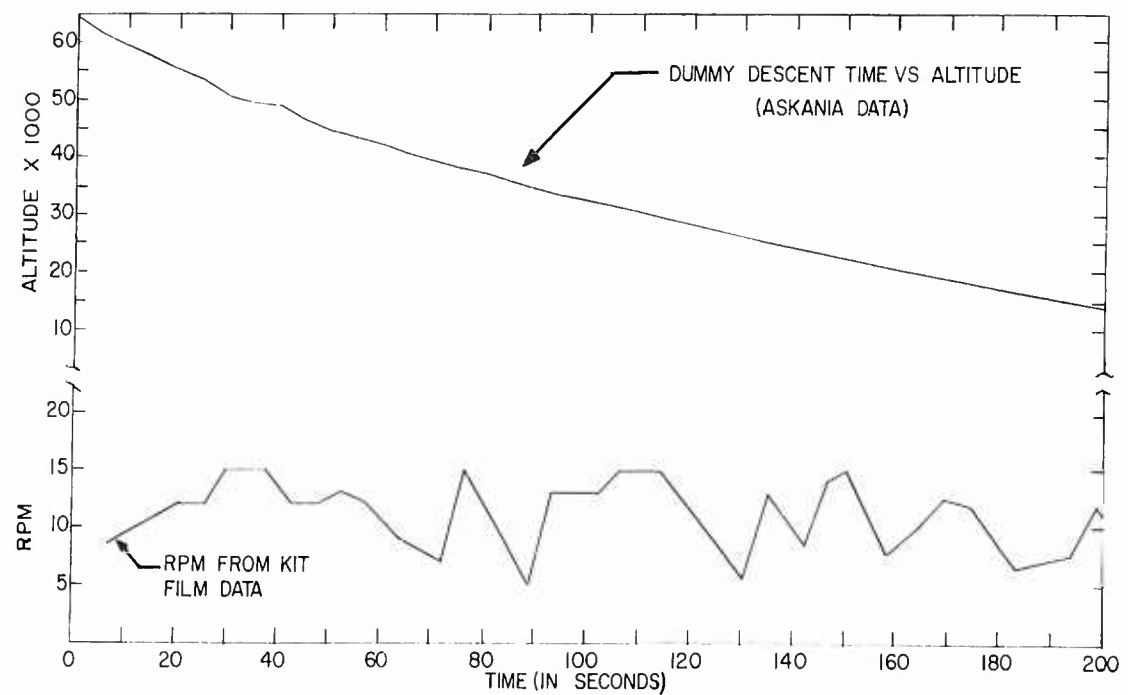
Figure 20. Series III. Data Reduction Sample, Dummy Number 1, Drop Number 067

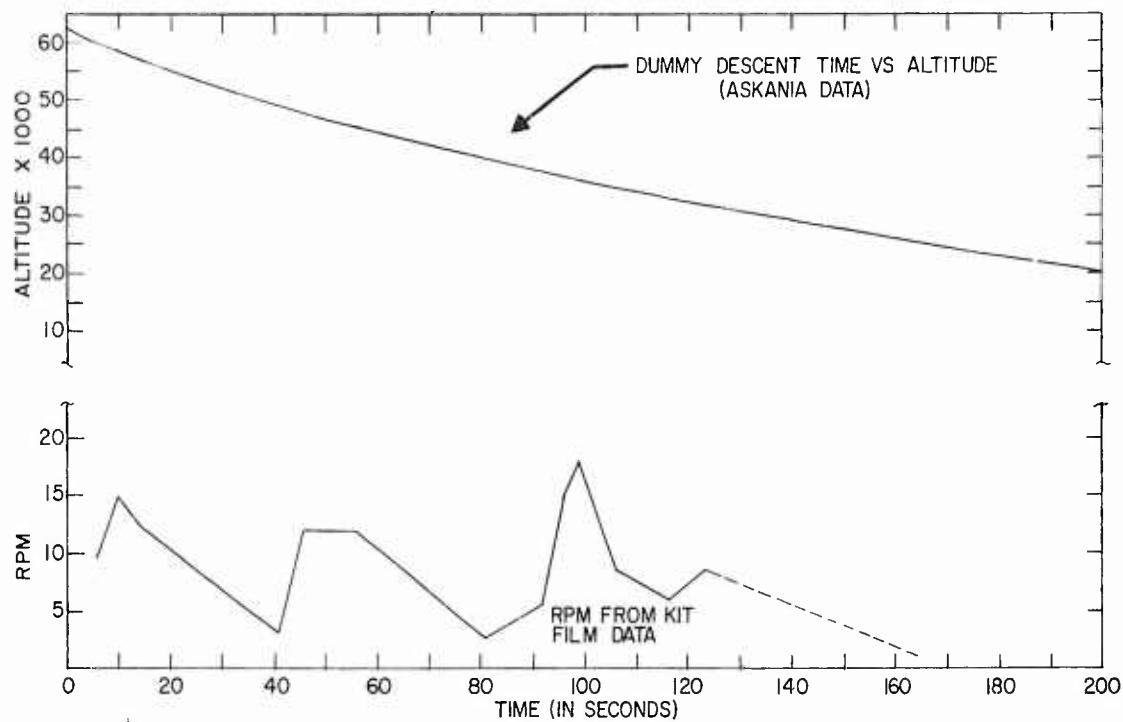
Figure 21. Series III Data Reduction Sample,
Dummy Number 2, Drop Number 067

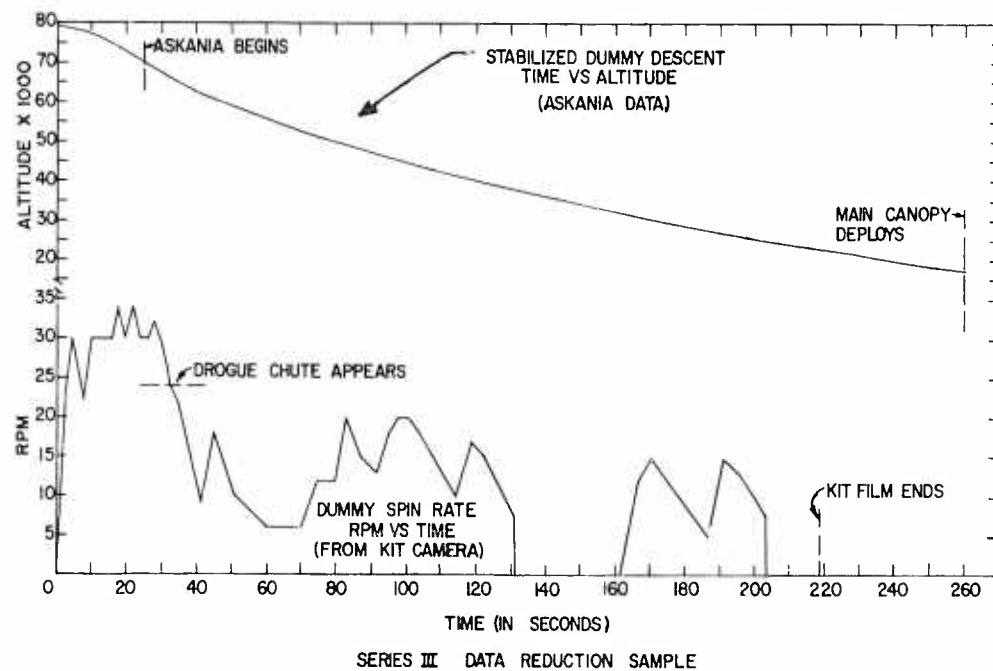
Figure 22. Series III Data Reduction Sample,
Dummy Number 2, Drop Number 068
